# **SOHAM NORTHFIELD WINDMILL**

## **A SUMMARY OF ITS MILLWRIGHTING HISTORY**

D.L. Pearce

27<sup>th</sup> December 2011

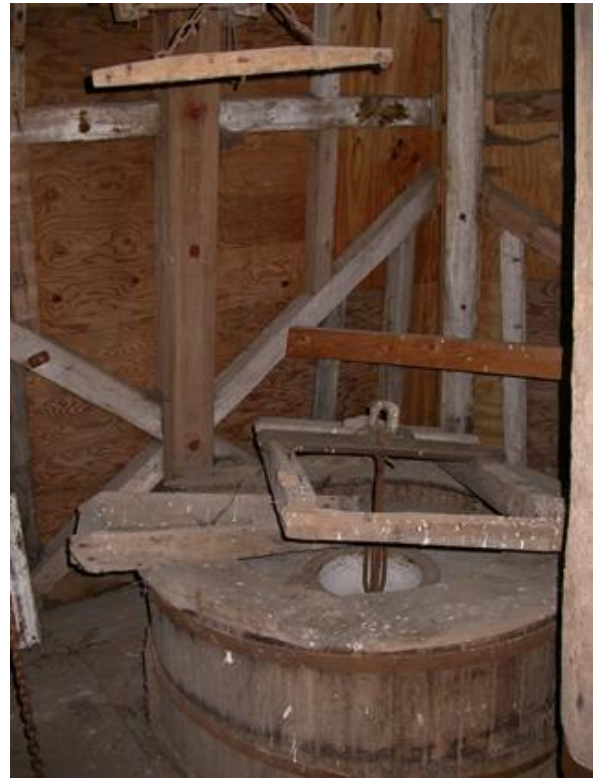
**Fig.3 Strengthening and re-cladding the smock (G.C. Wilson holding operation): additional framing, and plywood cladding.**

By 1973 the remaining pair of sails was reduced to a broken stock, and the smock tower was in urgent need of strengthening and re-cladding (photo in Smith, 1975). Mr G.C. Wilson of Over Windmill instigated a major project with the then owner Mr P. Johnson to strengthen the smock. In this emergency holding operation beginning in 1984 the old cladding of vertical boards and cover strips was removed, the rather light tower framing was strengthened by plating main beams where needed (not necessarily for the first time) and where the frame was weakest adding additional beams to strengthen the structure. The whole assemblage was further strengthened by cladding the smock in plywood sheets, nailed on to the framing (Fig.1 & 2).<sup>7</sup> Chris Wilson and Pat Johnson completed this work on all six sides of the smock, leaving it with a smooth plywood exterior. They then applied a coat of bituminous felt to weatherproof the smock.<sup>8</sup> This major holding operation ceased before any outer cosmetic cladding was applied.

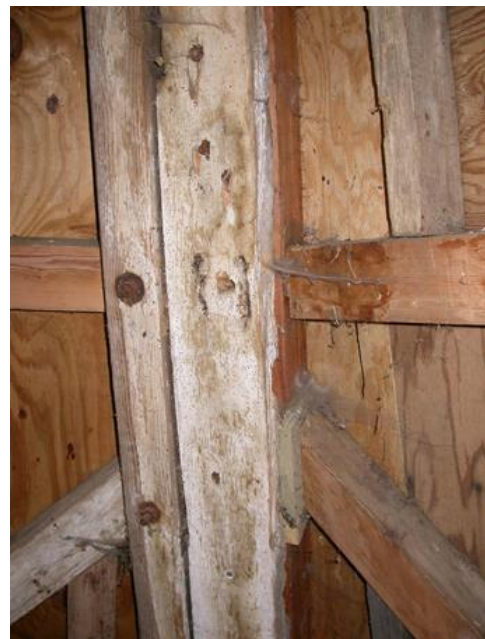
**Fig.4 Strengthening & Re-cladding the Tower (G.C. Wilson holding operation): plating a cant post and cladding with plywood sheets**

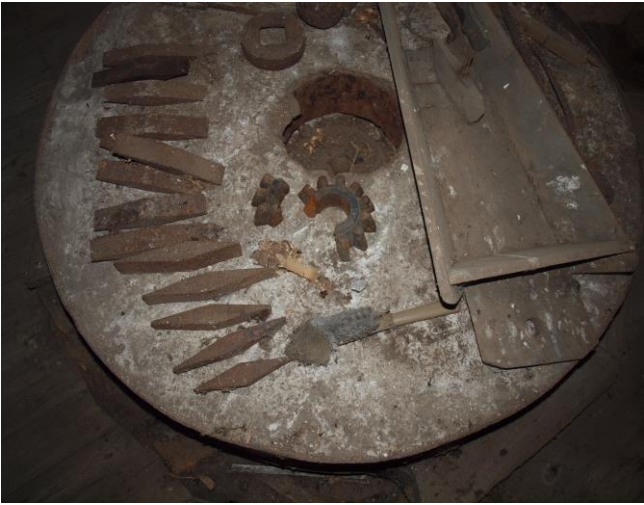
**Fig.5** Miscellaneous items on one of the millstones, including the broken fantail pinion

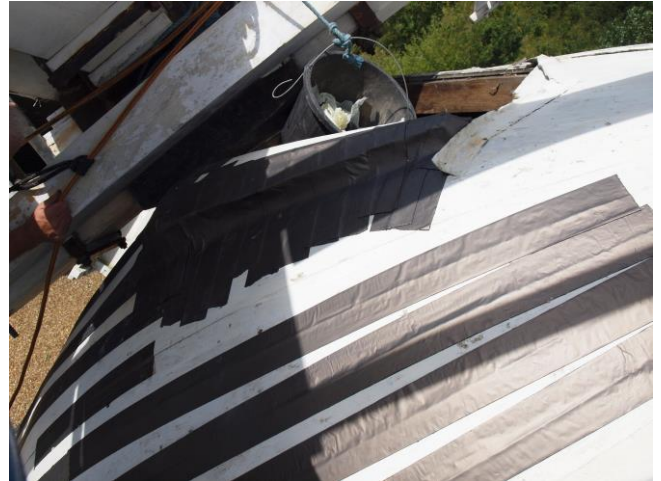
Any weakness in the front parts of the cap framing will allow the sails to subside over time. A common path for this to happen is that the combined weight of the sails and windshaft forces the neck bearing downwards and forwards, ultimately through distortion of the weather beam. The central part of the weather beam is deformed downwards by the weight, and at the same time twisted forwards.

This has the important effect of rotating the tops of the weather studs forwards. *The studs are strong, and such movement will inevitably cause the cap roof to fail by forcing the studs through the roof.* At Northfield Mill this problem has manifested itself in two ways:

- The wooden boarded cap roof has ruptured either side of the weather studs (Fig. 4, 5)
- The cap roof as a whole has been distorted forwards. This has opened cracks in the roof, and is very noticeable towards the rear where the side fences of the fan stage have detached from the cap roof.

**Fig.7** Covering large hole caused by roof distortion

The incipient damage to structural timbers and floors resulting from years of weather ingress can be seen in Fig. 8 - 12. White fungus, symptomatic of continuing excessive damp, is apparent on the beams. Considerable efforts were made in September 2010 to stop the holes in the cap roof using commercial builders' adhesive tape 'flash band' (Fig.6,7).<sup>10</sup>

<sup>10</sup> Recently animals, probably grey squirrels, have damaged the flashband over the roof holes, presumably in the interest of gaining access to the cap. A potential holding operation task for 2012 would be to replace the flashband in these areas by carefully shaped soft aluminium sheet.

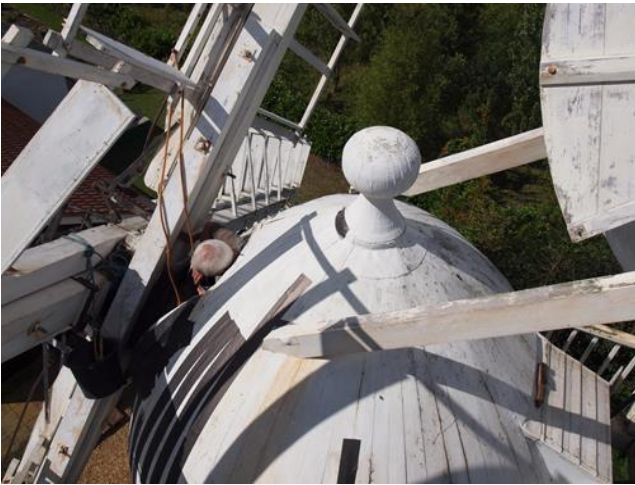
**Fig.6** Covering gaps in the roof with flash band

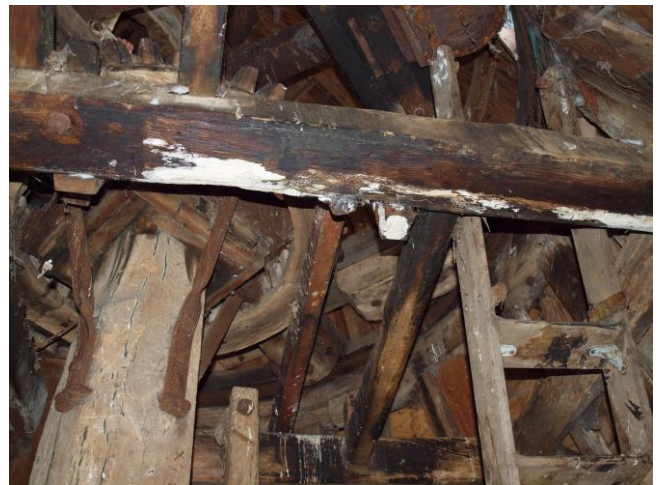
**Fig.8** Beginnings of fungal attack on beams of hursting near tower top, caused by many years of damp ingress

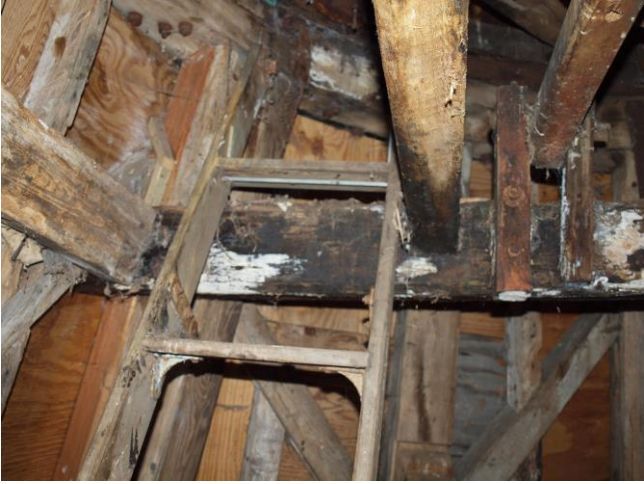
**Fig.9 Fungal attack 2. Other side of hursting beam, and curb**

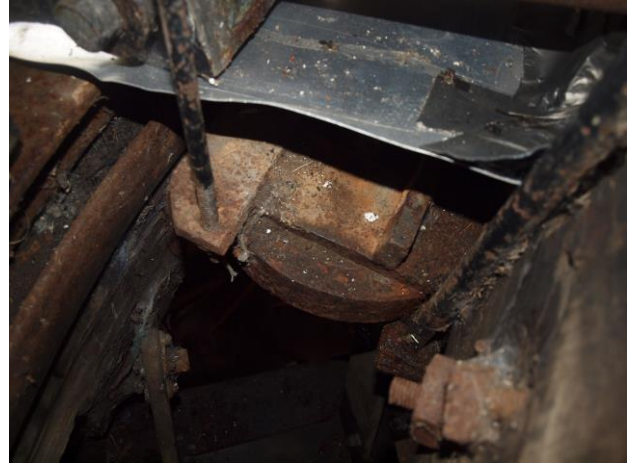
Investigation showed that water was not only entering through holes in the roof. It was also driving in down the striking rod hole along the centre line of the cast iron windshaft (carrying the sails). Some of the water could be ducted away by making and fixing an aluminium chute, which was attached to the windshaft tail beam just below the striking rod outlet. There was just sufficient height available to direct the water outside by taking this chute over the top of the smock tower.

**Fig.11 Holding Operation aluminium guttering, instasly to channel rain water out of cap and over top of Curb**

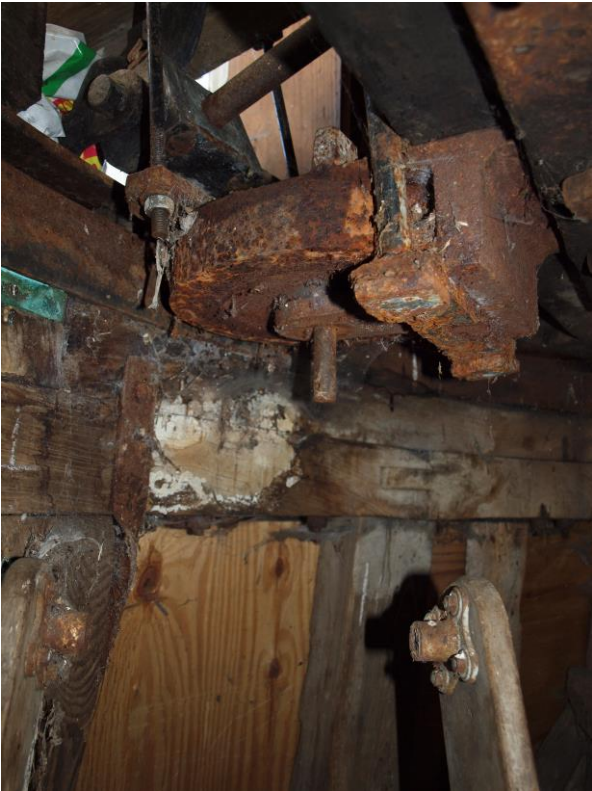
- Problems of concentricity in combination with the old curb not necessarily being true and level meant that occasionally the cap seized up as the fantail attempted to turn the sails to wind. This eventually led to the breakage of one of the cast iron centring wheels. The wheel was replaced without resolving the underlying engineering problem. It would appear that soon the cast iron bevel pinion on the fantail shaft broke up as well (Fig.5). The fantail was then tied up permanently.
- The weather beam, that is the front main beam of the cap frame, distorted under the weight of the sails. NB The sails, windshaft and brake wheel weigh around 4 tonnes, even in their restored state with shortened sails only partially shuttered<sup>9</sup>. This weight is mostly taken by the weather beam. Here it is important to understand features of this kind of Hunt Brothers cap:

**Fig.10 Curb, and pronounced rusting of rear cap Centring Wheel**

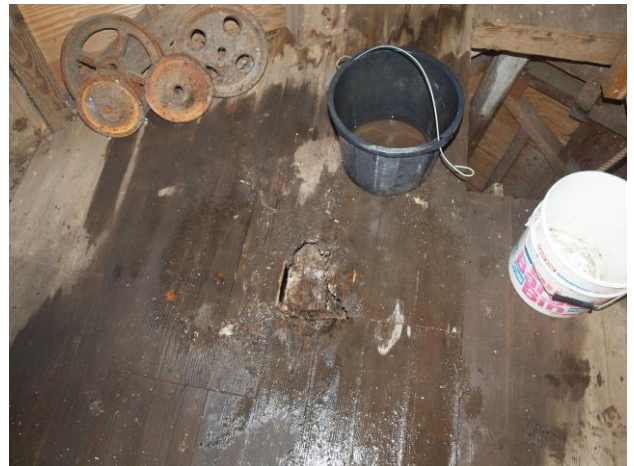
**Fig.12 Damage to Bin Floor, from continual wetting**

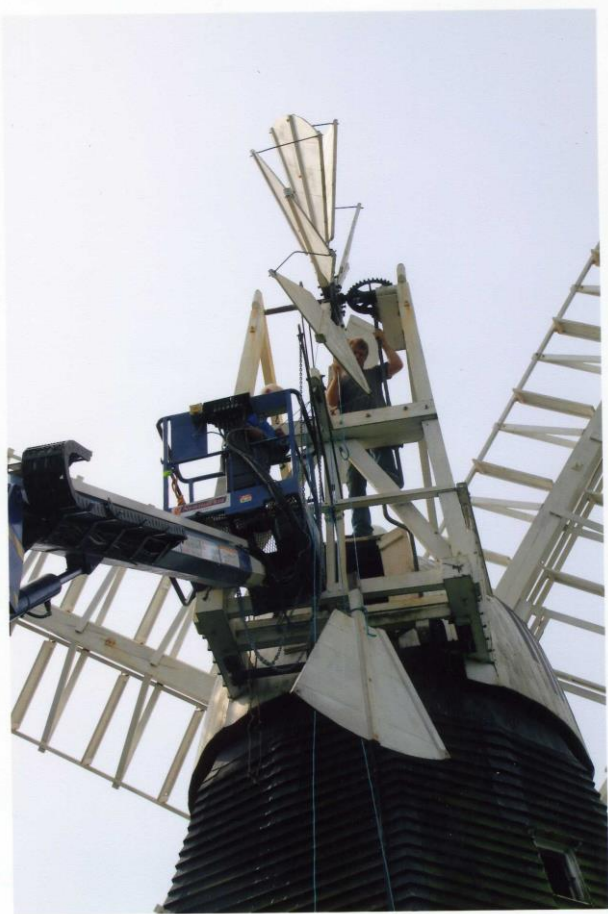
**Fig. 13 Lowering a fan blade for storage (R. Bramley in 'cherry picker, A. Kite on cap)**

A second major task carried out in September 2010 was to take down the fantail blades and inter-blade tie irons carefully for storage (Fig.13). The full size fantail had been tied up for many years. Bearing in mind the large sails and small cap, and history of cap loss through tail winding, and that the cap will not be able to turn without major restoration of both cap and tower, it was decided with some reluctance to dismantle the fantail. The blades and irons are stored in a large shed nearby on the property. NB We were concerned not only about the possibility of tail winding ... this concern could be resolved permanently by fitting restraining dog irons at the rear of the cap to stop the cap lifting ... but also about the impact of heavy side gusts on the fixed fantail. The cumulative impact of these gusts over many years could easily rip blades off the fantail.
