Broads Mill Repairs – Problems of maintenance and suggestions for prolonging the life of repairs.

V.G. Pargeter, Millwright, Chelmsford, Essex.

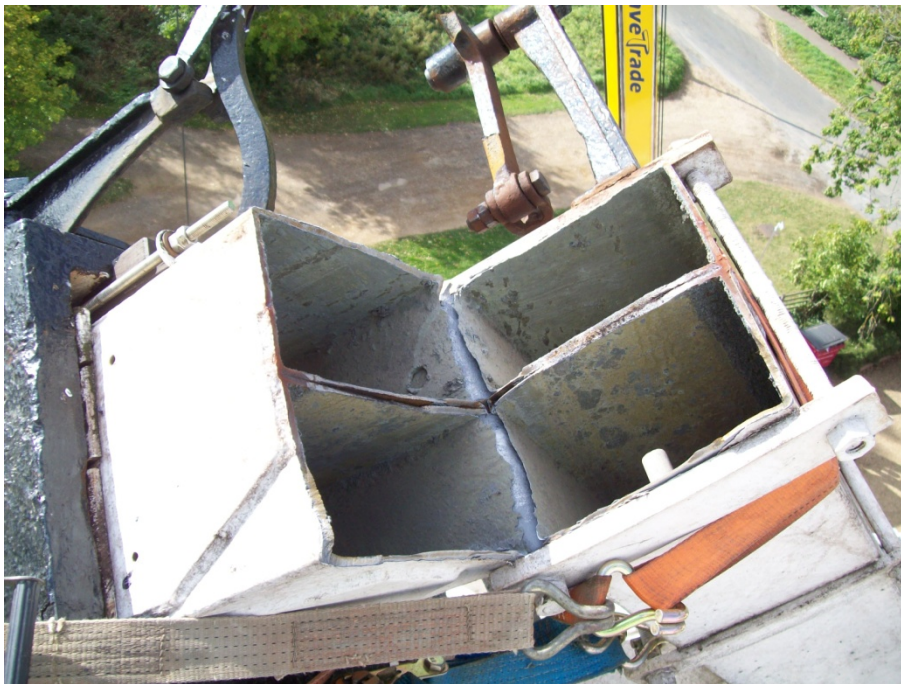
Broken steel stock at Denver Mill.

Despite these changes, the breakage of a steel stock on the working mill at Denver in 2011 showed that the design was still inadequate. Lessons learned were: Sudden changes in the thickness of the steel must be avoided, full-sized sails need to be attached by 4 bolts rather than 3, galvanizing is essential to prevent rusting. In addition, Denver Mill had no clamps, despite having had them in its old working days, and these would have prevented the breakage.

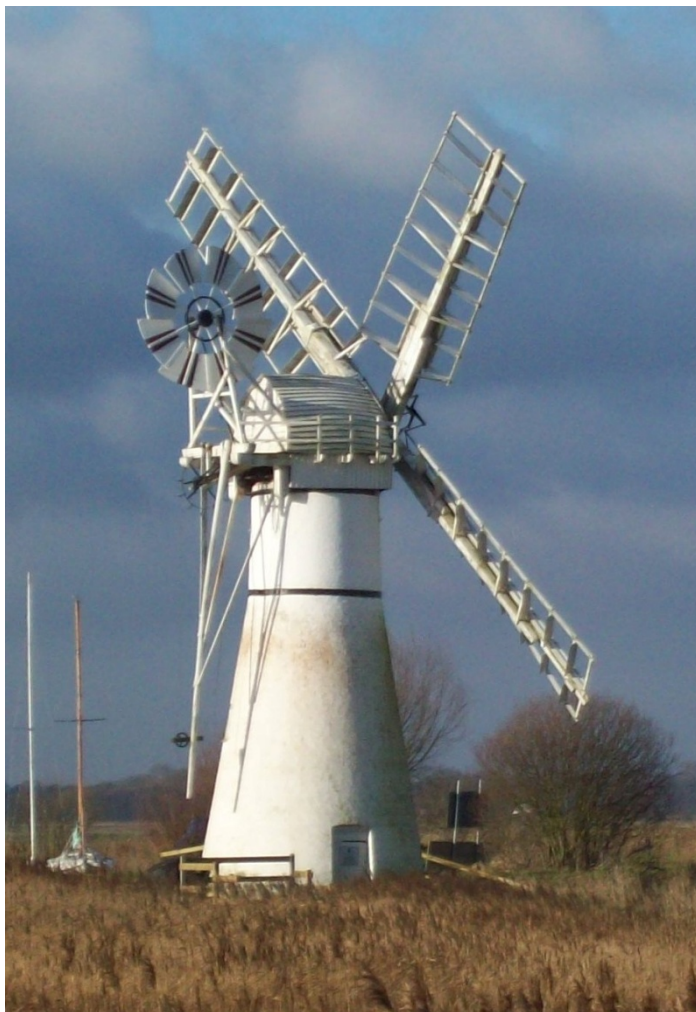
Thurne Mill with steel stocks and wooden clamps.

All Broadland mills had pairs of long wooden clamps to reinforce the stocks at the centre. Clamps can still be made from good quality air-dried home-grown timber and treated against decay, and it is proposed that the use of wood is continued. In the past, a combination of through-bolts and encircling cramps were used to fasten the clamps in place. It is proposed that the through-bolts be omitted and replaced by extra cramps to avoid boring holes through the timber. All steelwork needs to be hot-dip galvanized.

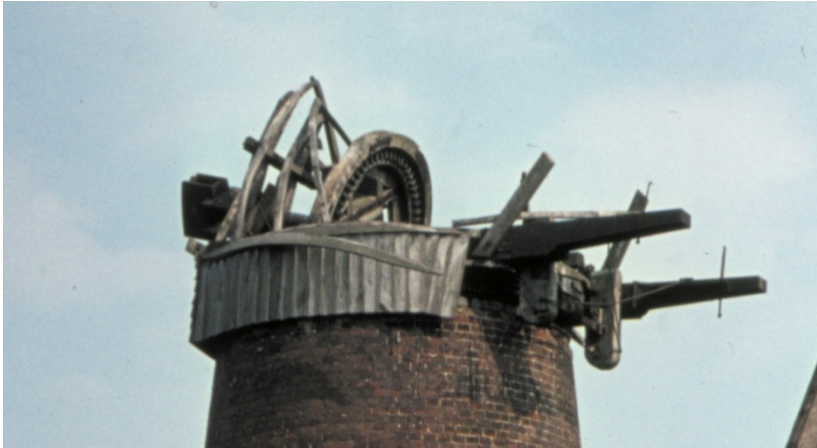
Cast-iron sheer extensions at Neave's Mill.

The old millwrights recognised this, and started to make the sheer extensions from cast-iron as seen at Howard's Mill, Halvergate and Neave's Mill, near Ludham Bridge.

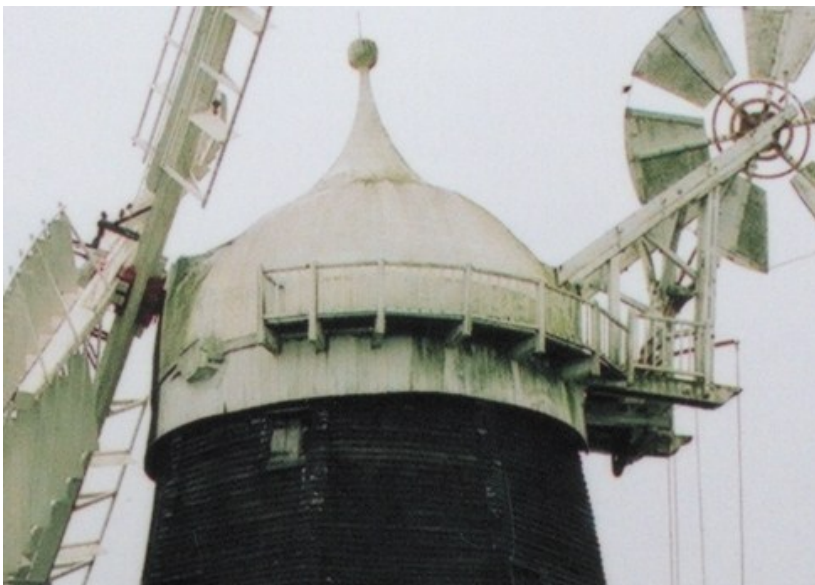
GRP coating to the cap at Willingham Mill, Cambs.

As an alternative, the traditional weather-board covering could be retained, but suitably bevelled to remove sharp corners, and covered in glass reinforced plastic, pigmented white. This would retain a good appearance inside and out, and provide the

necessary weatherproofing. This method has already been carried out on several mills e.g. Denver, Willingham, Swaffham Prior to mention just a few. Thus existing old caps have been kept weatherproof where they would have needed a costly rebuild with the loss of original fabric. New caps could be protected in the same way. The G.R.P. bridges over the many joints in the timberwork, and is a long lasting material. G.R.P. has been in use for roofing for many years, and offers a 50 year life, with only occasional painting to maintain the surface and appearance. Any damage can be repaired easily without dismantling. A G.R.P. skin requires less skill to apply, and the weatherboards beneath can be of standard quality. An alternative covering would be high-purity aluminium sheet. This could be dressed over the weatherboarding, and fastened with aluminium alloy nails. Joints could be overlapped and bedded on mastic. The surface could then be primed and painted white.
