KENT WINDMILLS EDUCATION PACK

Kent Windmills: A unique community resource

The Story of the Kent Windmills

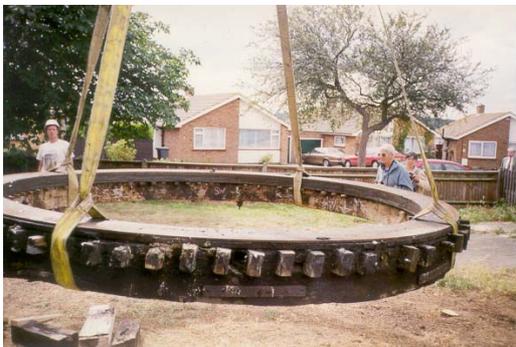
The old curb and cogs removed for rebuilding

repaired, including replacing the steel stocks with lighter laminated timber, much more suitable for the delicately constructed Kentish smock and cap. The EH funded work involved the repair and replacement of the failing smock curb and timber cogs. Bretts

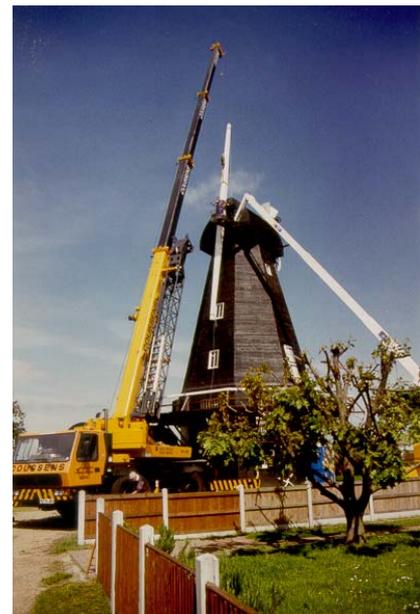
Fitting new laminated timber stocks

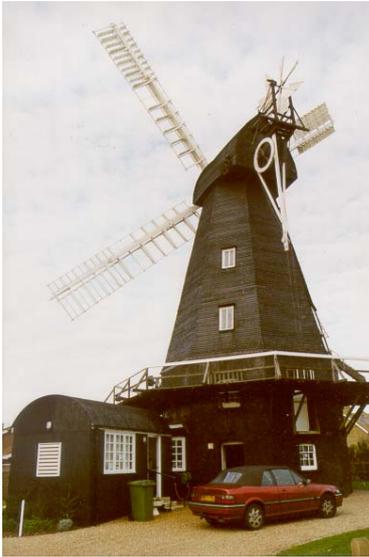
The work completed

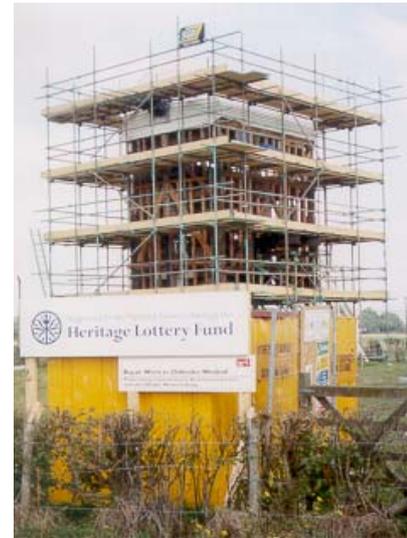
Work in progress

The mill had suffered over many years from superficial repairs, sometimes carried out by local builders rather than a millwright. As a result repairs were done without dealing with the basic problems. The most important alteration and one of which compromised the mill's structural continuity, was to wedge the

post to the cross trees below and secure the tail pole to the ground with a steel post. This prevented the body moving independently on its trestle. As a result, the mill body suffered further and with beetle and water damage the mill frame was becoming dangerous.

The repairs have now been completed. This includes re boarding and extensive repairs to the frame, trestle repairs, replacing a stock, rebuilding sweeps and replacing shutter frames and shutter furniture. As part of an ongoing experiment comparing alternative coatings and materials, the mill body has been painted with a white lead paint, whilst the stocks and sweeps have been painted using a natural pigment made up of titanium dioxide, zinc oxide and chalk, suspended in raw linseed oil.

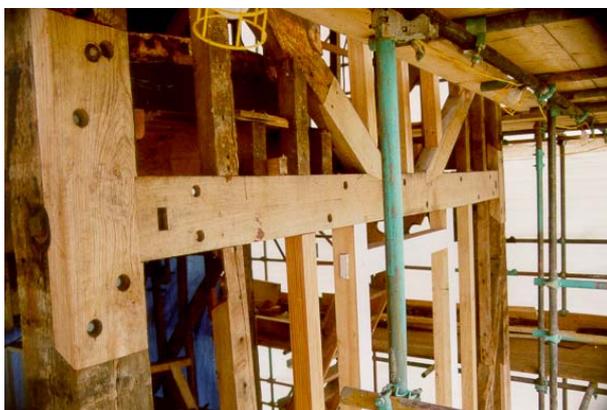
Major frame repairs

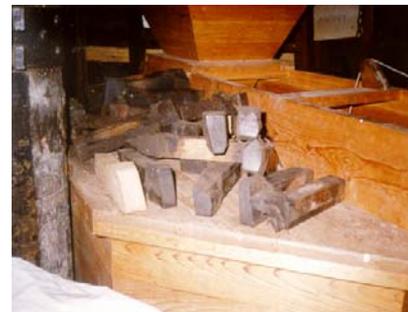
The original Curb Cogs

When surveyed, the mill was found to be in reasonable condition. The weatherboarding, though not tarred for many years, only needed replacing on the cap and minor repairs were needed to the structure. I took the decision to remove the cap in any case and as a result the cap frame and smock curb and curb cogs could be properly assessed. This exposed structural problems that had to be dealt with because the cap is unlikely to be removed again for many years. The breast beam and one failed rib has been replaced and one other rib part-replaced with a wedged scarf matching the other ribs. All the timber cogs have been replaced in the smock curb. The fact that the mill continued to turn satisfactorily for many years is very much to the credit of the original builders particularly since some of the replacement cogs were made from mahogany furniture legs.

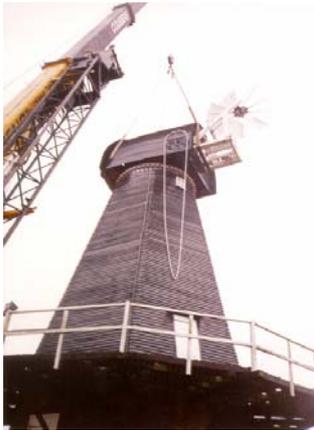
***Replacing the Cap
on 17 October 2002***

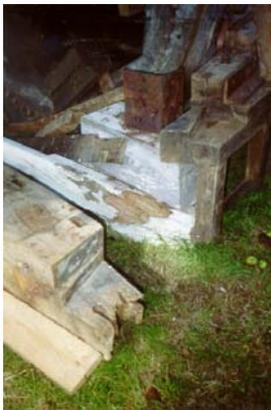
***Junction of the
Breast Beam and
Shear showing
failed dovetail***

The opportunity has been taken to improve the weathering details of the fan stage frame and modify the weatherboarding at the cap ridge, the latter being a weak point for water egress in all our mills. Late in the contract, removing oak slats on the reefing stage exposed wet rot in the supports. Replacement of these and all the slats was considered essential. In order to extend their life, the supports have been tarred and new oak slats bedded in wet tar.

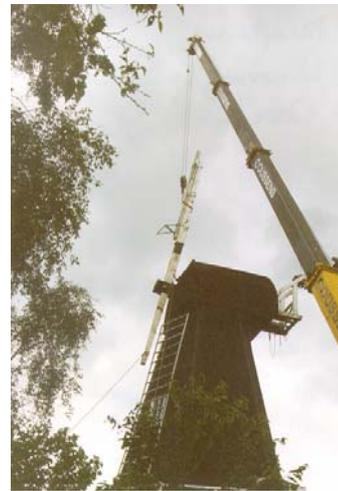
Removing the Steel Stocks

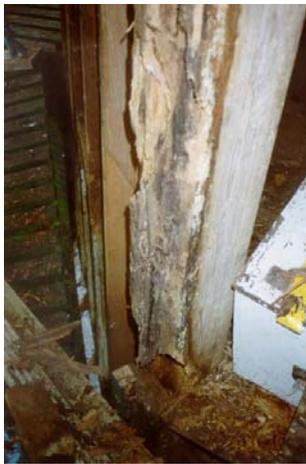
Timber failure on cant post

Of all the mills in KCC ownership, this appeared to be in the best condition. The only clues as to possible problems were permanently damp weatherboarding and moisture on the surface of three structural posts. Limited areas of wet and dry rot were also visible. It was only when the cap was removed and the weatherboarding stripped off, that the true extent of the problems were revealed. In the 1970's the mill was painted in plastic paint on the original tar. This sealed the boarding including the joints between boards and prevented the mill breathing. As a result the water entering at the cant posts where the butt jointed boarding had failed could not dry out and massive damage to the outer concealed face of the posts was present. Removing the boarding also exposed holes for which no obvious cause was discernible, until the sight of a mouse explained all. When the cap was removed, and this was done during the village fete as an extra event, stress in the cap frame was discovered. Removal of the

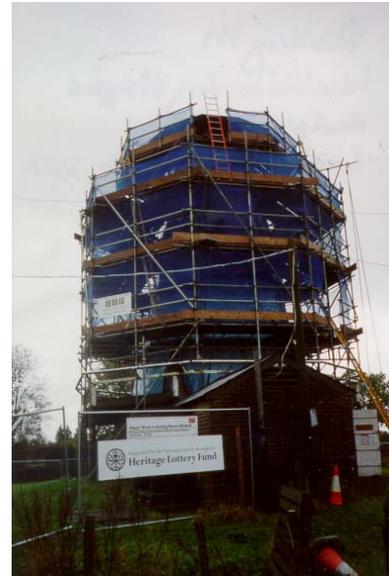
Weatherboarding stripped and frame repairs continuing 17 October 2002

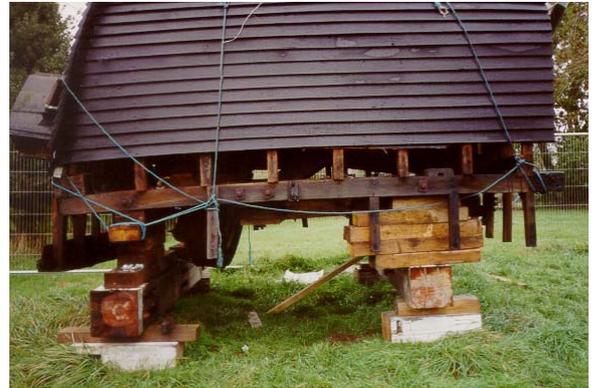
boarding exposed a problem common in many Kentish Mills. The side sheers are of too small in section and bend with the weight of the breast beam and wind shaft at one end and the fantail supports at the other. It is probable that the cap is stiffened by the weatherboarding, but a decision on possible strengthening of the frame needs to be taken before re-boarding is done.

Bending of sheers to Cap

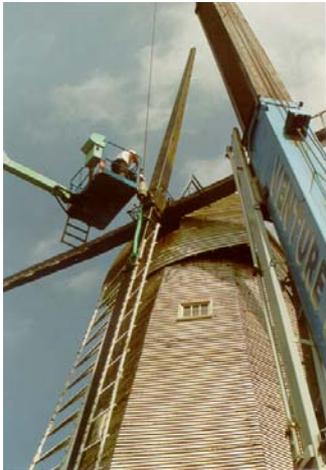
When restored in the 1960's, only a Dutch millwright was available to carry out the work. As a result, a pair of Dutch style combined sweeps and stocks replaced the Kentish originals. Over the last two years, some of the sail bars and shutters were failing and, as an emergency measure, these were removed before last winter. Work has now begun on the main contract with removal of the steel stocks and sail frames. The existing white painted weatherboarding is failing due to the use of a modern paint on wet boarding. Early in 2003, the cap will be removed and repaired under cover off site. The mill will be scaffolded, the boarding removed, the structural frame repaired where damp has promoted extensive rot. The cap and smock will then be completely reboarded. Traditional

Removing the Dutch sails

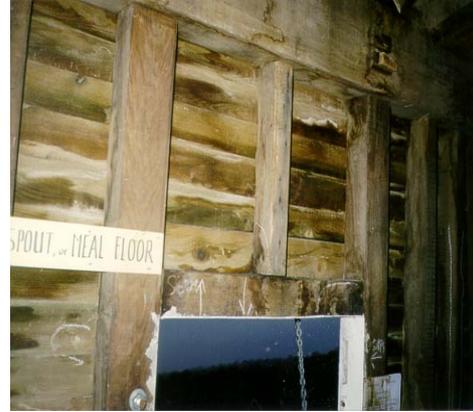
Sodden and failed weatherboarding

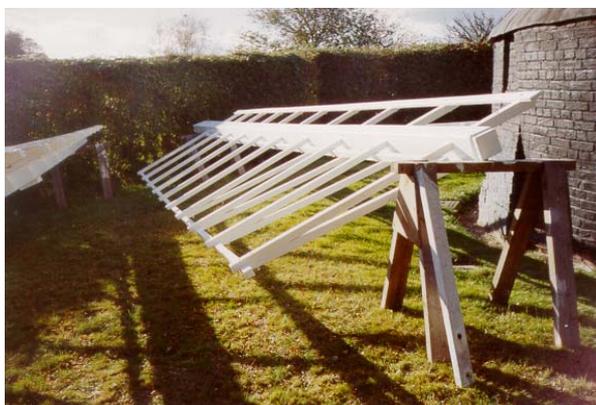
Sweeps removed for repair

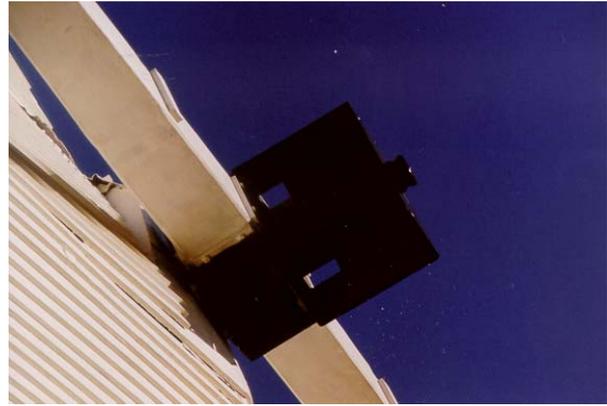
Canister - large and heavy for the size of mill

Work is now under way; the mill has been coated with traditional lead and linseed oil paint. The previous lead coating has lasted very well and once the powdering top coat had been removed, further protective coats have been easily applied. Two new sweeps are under construction. The original mill floor, badly damaged by wet rot will be revealed under a modern timber floor. It will be recorded before removal and replacement by sound boarding. Internal furniture will be replaced and the sprattle beam relocated in its correct position to properly align with the stones below.
